Figure 2 – East and West Project Sites Showing the Proposed Development, and the Verified Fault and the CGS Hollywood Fault Crossing the Project Site

DATE: 8/5/2014	DRAWN BY: KM	GROUP DELTA CONSULTANTS, INC. 370 Amapola Ave. Suite 212 Torrance, CA, 90501	BORING, CPT, CROSS SECTION AND TRENCH LOCATION	PROJECT NUMBER: LA1191A
REVISION: 10/31/2014	APPROVED BY: MR	DELTA	WEST/EAST MILLENNIUM SITES	SCALE: AS SHOWN
REVISION: 2/28/2015	Modified from GDC, 2014a			PLAN NUMBER: 1

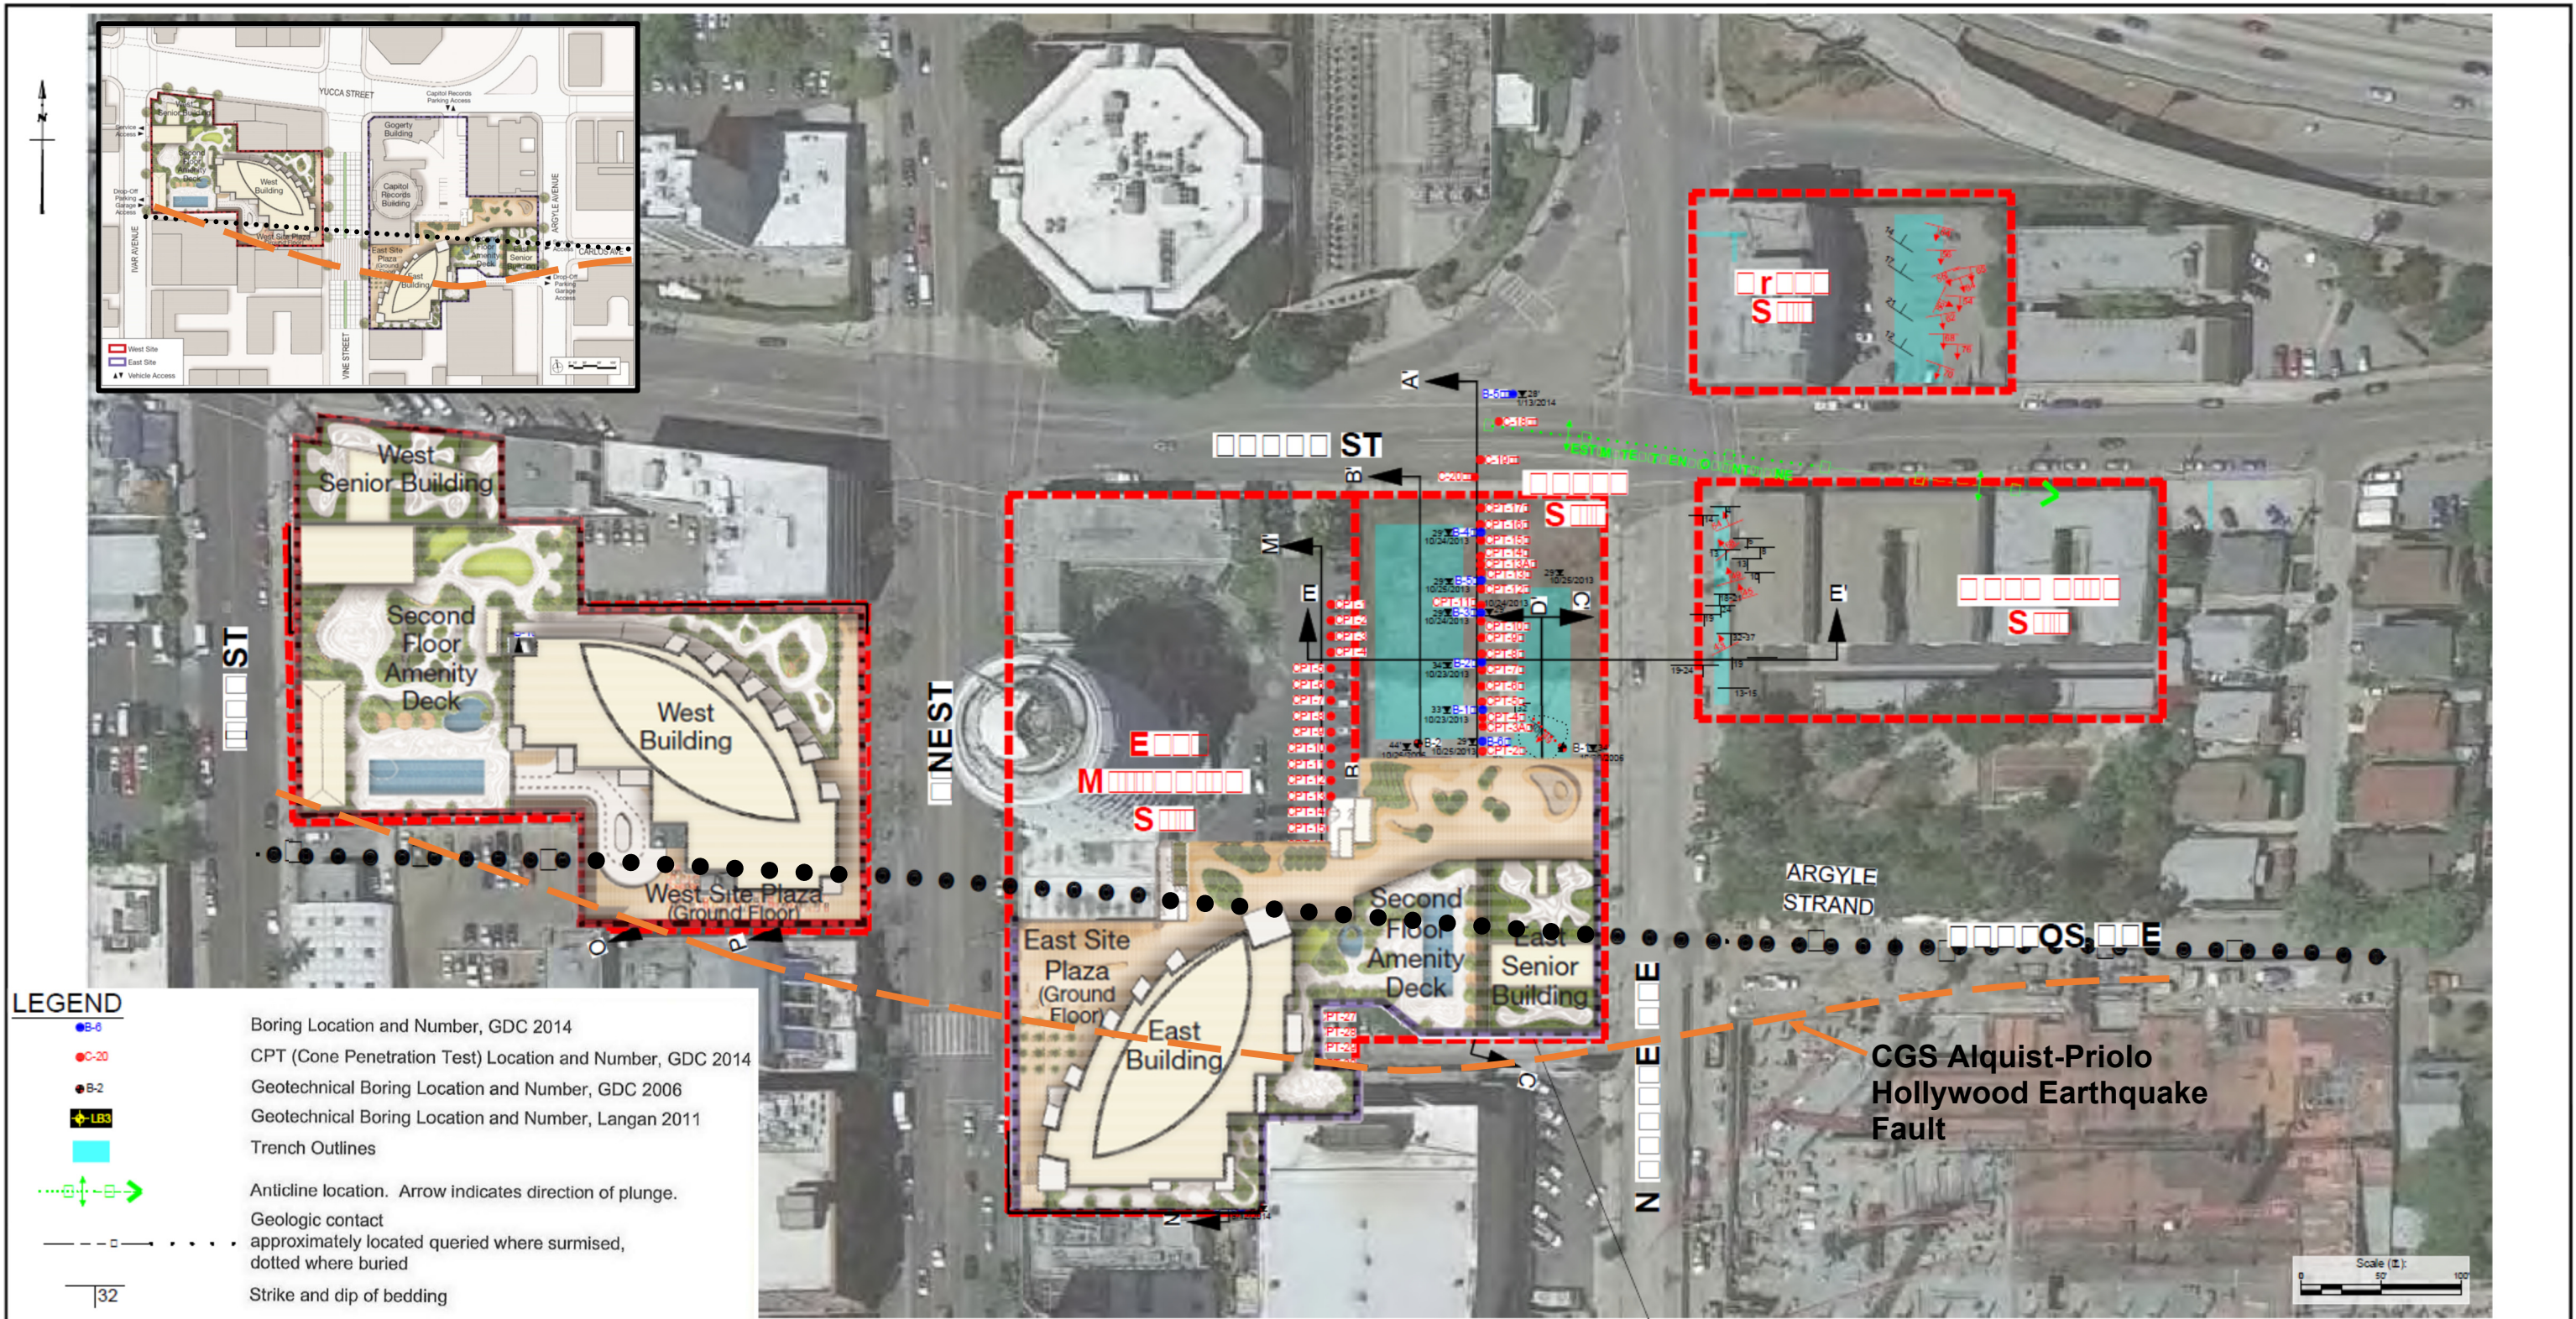
Explanation – This is the GDC 2015 site map (Plate 1) showing the proposed development with respect to the location of the CGS/GDC agreed upon (May 17, 2015 response letter to City of Los Angeles) location of the continuous fault (large black dots) that passes through the East Senior Building, 15-feet north of the East Building tower, through the south edge of the West Site Plaza Ground Floor, and 30-feet south of the West Building tower. The APEFZ Hollywood Fault (orange) crosses within 50-feet of the East Senior Building, through the center of the East Building, and through the south edge of the West Site Plaza Ground Floor.
